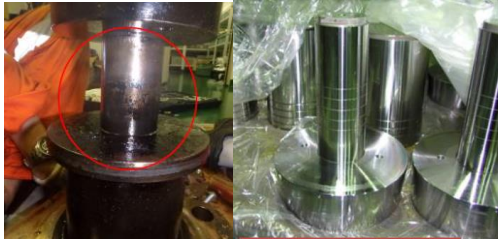
Through checking the surface of plunger and cylinder surface on high-pressure pump cap, no scratches, roughness, mechanical edges are detected. Signs of scale on the plunger body on the lower and top part of the hydraulic piston show that the fuel leaks down, grips and traps. Leakage position can be from sealing gaskets or from the plunger work surface itself.

Figure 7: Plunger status is stuck and new[23]

Maintain fuel pressure according to manufacturer's instructions (~ 10 bar)

When operating at low load, the daily load should increase the load more than the prescribed time, increase the load slowly and up to 75-85% load.

Maintenance and replacement of sealing seals according to the plan are shown in the instruction manual.

Check fuel quality to ensure components are harmful to plunger's working surface.

Fuel pressure monitoring if detecting any fluctuation, attention should be paid to leakage, especially when running at high load and when operating with LS MGO.

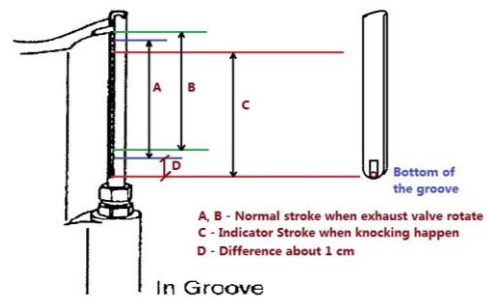
Figure 8: Journey of the exhaust valve when a problem occurs[24]

Distance A: The movement of exhaust valve (from the closed position to fully open)

Distance B (A = B): Regarding meaning B is similar to A but because the indicator bar rests on the high end of the winding cylinder.

Distance C: The distance from the position completely closed to the position where the indicator bar is limited due to the slot.

For some reason, a discharge valve does not close all on the closed journey, resulting in that cylinder does not burn, does not give birth. Only five cylinders are left, causing the engine speed to fluctuate strongly, the amount of fuel supplied to the cylinder increases to ensure maintaining the set speed.

The deafening impact in the inner cylinder is caused by a collision between the seat face and the valve seat due to the impact of a tremendous force when closed again.

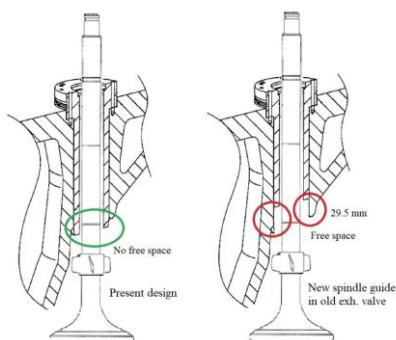
**Figure 10:** Space when changing the guide pipe according to the new design[26]

- Replace hydraulic hose connectors to increase sealing and loosening capabilities
- Replace hydraulic hoses with larger diameters
- Replace the conduit guide pipe to increase heat transfer capability. The essential feature of the new design is the shorter guide pipe, the larger inner diameter.

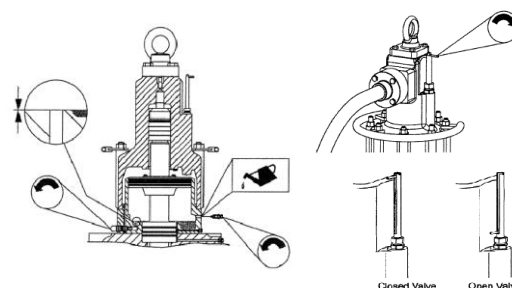
**Figure 11:** Some attention when maintaining exhaust valve[27]

Check the surface state of the tip, the working part with the maintenance guide pipe to see the level of fouling, soot, fire, and wear (if any).

Check the condition of the seal and throttle holes on the top of the valve during maintenance.

Monitor the impact of MEV-piston on the display screen and the position of the ELFI control valve.

The valve replacement process should take into account the "air spring" level before running the lubricant pump. Otherwise, the value of the closed and open corners of the valve may be changed.
