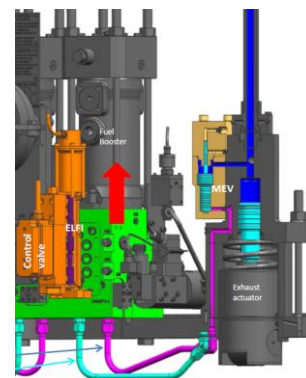
Figure 9: Arrangement of ELFI valve and MEV piston to support for exhaust valve control [25]

About a few seconds or later, a powerful impact is heard on the engine discharge side, after which the engine speed returns to normal, but the phenomenon can be repeated continuously, or the motor speed is ceaseless.

In typical load mode (65-80%) when the sea voyage does not occur.

For some reason, a discharge valve does not close all on the closed journey, resulting in that cylinder does not burn, does not give birth. Only five cylinders are left, causing the engine speed to fluctuate strongly, the amount of fuel supplied to the cylinder increases to ensure maintaining the set speed.

The deafening impact in the inner cylinder is caused by a collision between the seat face and the valve seat due to the impact of a tremendous force when closed again.

Until now, manufacturers have not identified the cause of the phenomenon. The manufacturer makes some assumptions:

Low pressure "gas spring" pressure or leakage;

- Replace hydraulic hose connectors to increase sealing and loosening capabilities
- Replace hydraulic hoses with larger diameters
- Replace the conduit guide pipe to increase heat transfer capability. The essential feature of the new design is the shorter guide pipe, the larger inner diameter.

Enhance the hydraulic oil leakage test in pipelines from HCU to MEV piston.

Strengthen the leakage test of the spring wind in the air cylinder, the check valve on the supply (check in the engine stop state), recommend every 3 months. Abrasion on the cuff on the air cylinder or may result in the possibility of spring gas leakage, resulting in a change in the time of opening or opening of the cylinder, or a non-flammable cylinder due to incomplete closure, causing fungal damage, rolling valve because the valve does not close.

Enhance leakage test in "gas spring," the check valve on the exhaust valve (check-in engine stop state), recommend every 3 months. Abrasion on the seal on "air cylinder" or may lead to leakage of "gas springs," resulting in

the time of closing, opening the valve is changed, or the cylinder does not burn due to the incomplete valve, causing fungal damage, rolling valve due to the valve does not close.

Check the surface state of the tip, the working part with the maintenance guide pipe to see the level of fouling, soot, fire, and wear (if any).

Check the condition of the seal and throttle holes on the top of the valve during maintenance.
